**PROPOSAL FOR NO FURTHER ACTION  
ENVIRONMENTAL RESTORATION PROJECT  
SITE 22, STORAGE/BURN AREA  
OPERABLE UNIT 1334**

**June 1995**

**Environmental  
Restoration  
Project**

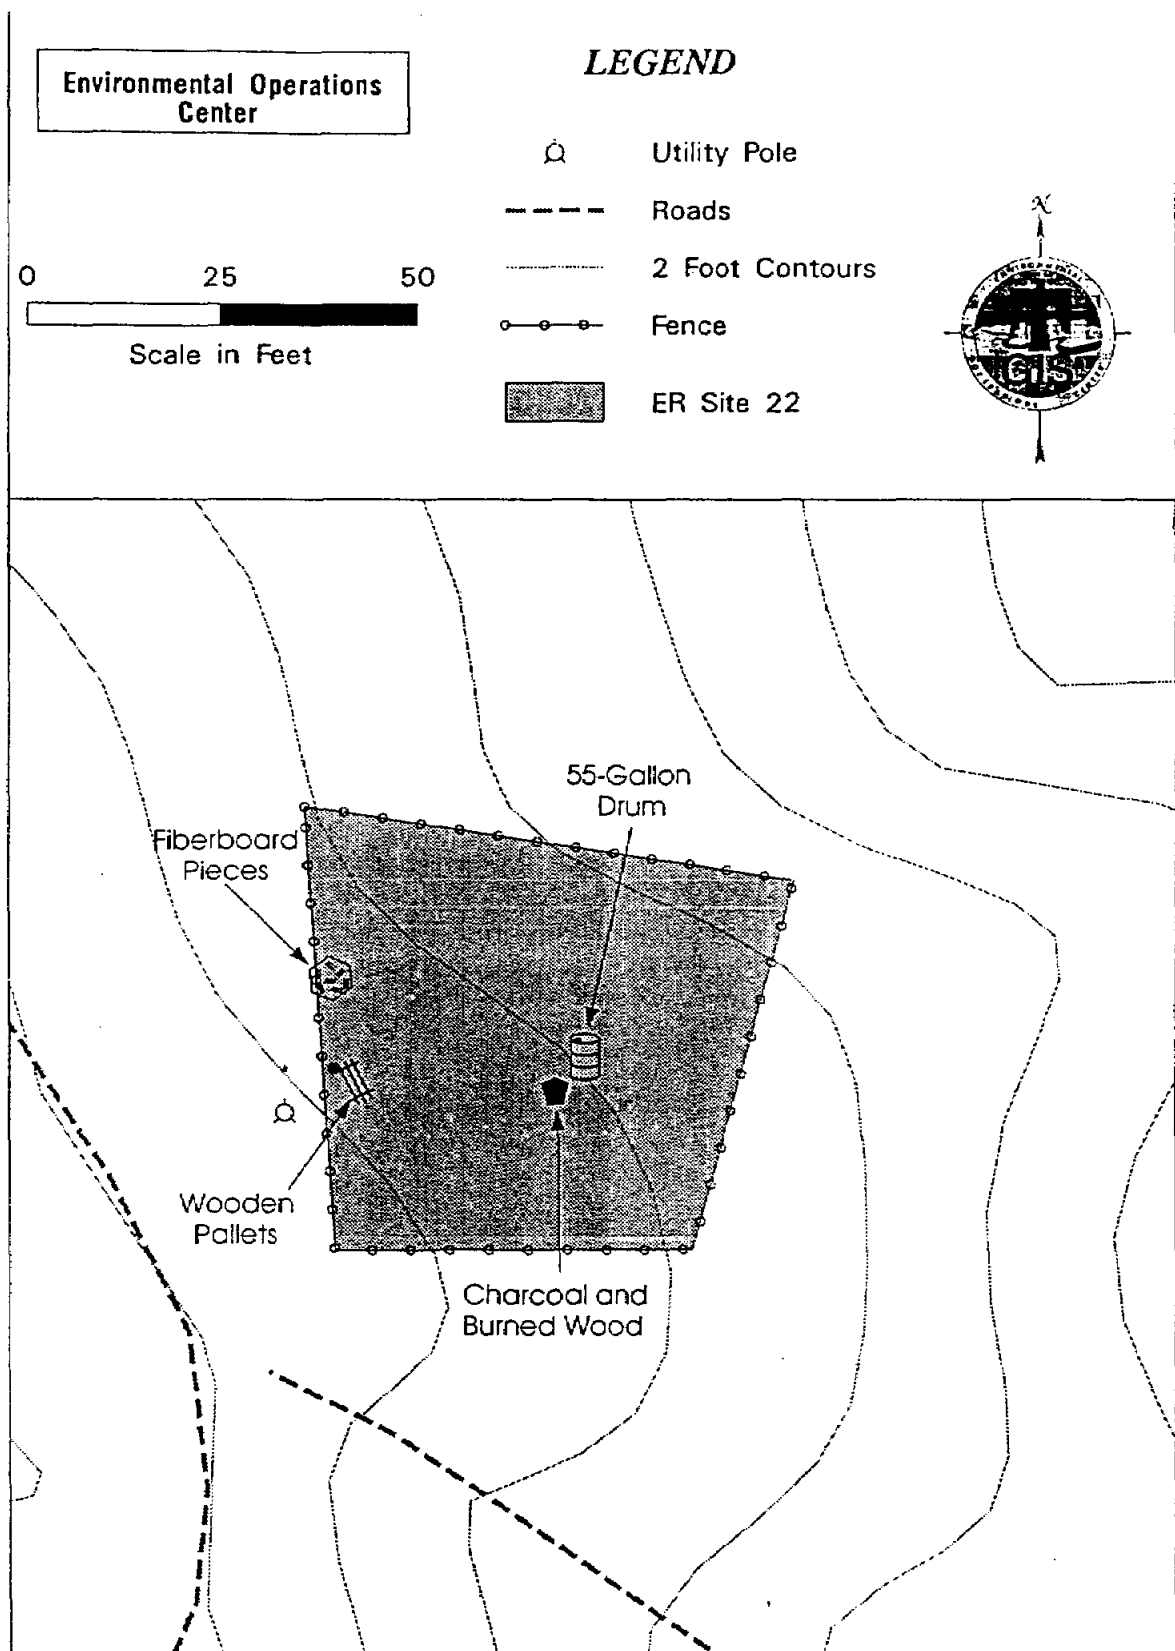
Figure 2-1  
ER Site 22, Storage/Burn Area

ER Site 22 (Figure 2-1) is a small, irregularly shaped fenced area, approximately 50 by 50 feet (Figure 2-2a). The approximately 3-foot-high, five-strand barbed-wire fence is in poor condition. No signs or placards appear on the fence, with the exception of the ER site posting. The area inside the fence contains one empty 55-gallon drum, several wooden pallets, charcoal, and scraps of fiberboard. The top of the drum has been cut off, and the bottom of the drum is discolored from heat, indicating the drum may have been used as a fire barrel. Charcoal is scattered on the south side of the fenced area (Figure 2-2b). The wooden pallets show evidence of past burning, but no burn pit is visible at the SWMU. It appears that the only burning that took place at the site was a small wood fire in the drum. A utility right-of-way cuts the southwest corner of the site and consists of overhead power lines and an underground fiber-optic cable.

ER Site 22 contains one empty 55-gallon drum, several wooden pallets, charcoal, and scraps of fiberboard (Figures 2-1, 2-2a, and 2-2b). The purpose of this unit is not known, but the materials present suggest the SWMU was used as a storage or staging area for local construction activities.

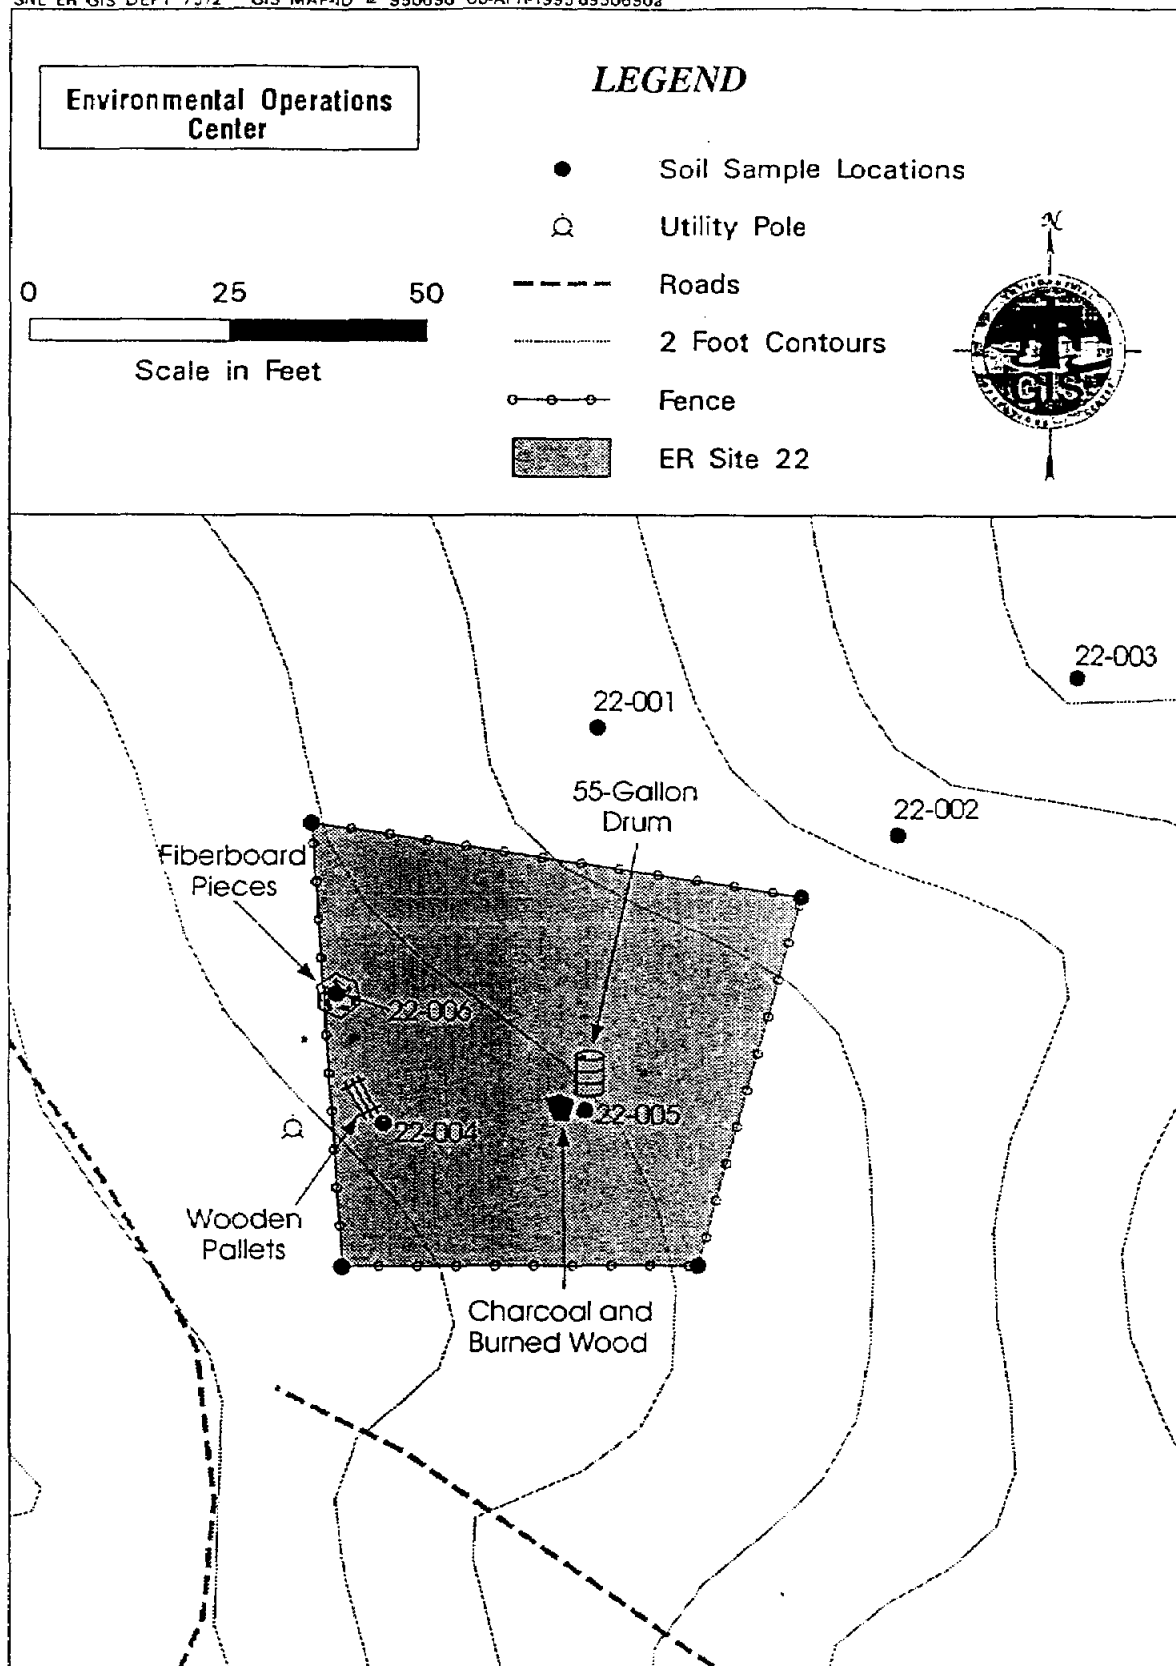
Figure 3-1. Sample Locations at ER Site 22

A PID monitor was used to monitor for the presence of organic (and some inorganic) vapor in air. The field screening locations are shown in Figure 3-1, and the field screening measurements are listed in Table 3-2. The background reading on the PID during the field screening for organic vapor was 0.3 parts per million (ppm). There were no detectable organic vapors at sample locations 22-002 through 22-005. The field screening measurement recorded at sample location 22-006 was at background (0.3 ppm) in the 0- to 6-inch interval. Organic vapor was detected at the background sample location 22-001 at 0.6 to 0.7 ppm in

Radiological screening was performed at all sampling locations shown in Figure 3-1. The field screening was performed with a G-M beta-gamma pancake probe and sodium-iodide scintillation detector in accordance with the methodologies prescribed in the sampling and analysis plan (Appendix A). Background beta-gamma activity was recorded at 12,800 counts per minute (cpm). Activities at both the background sample locations and on-site sample locations ranged from 9,830 to 10,600 cpm. In addition, these activities never exceeded the action level of background plus 2 standard deviations that would trigger collection of a soil sample for radionuclide analyses.

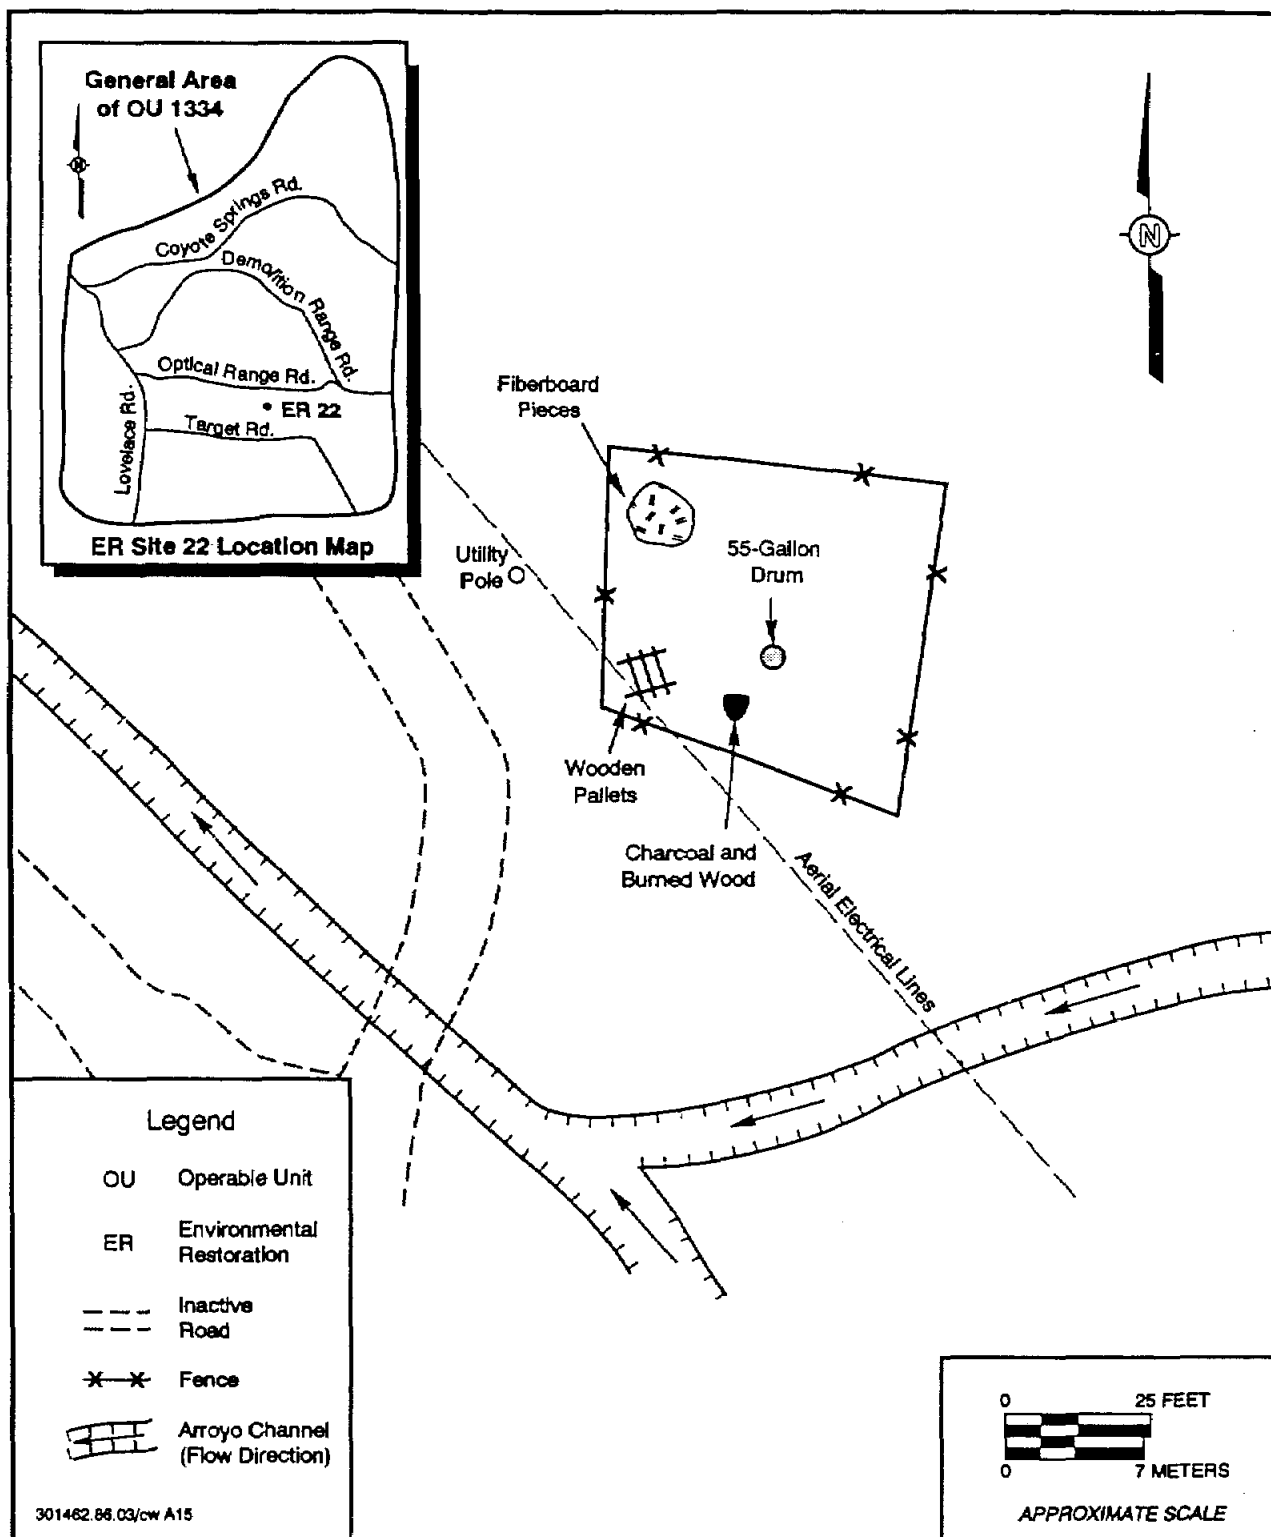
**Figure 1-1**  
**Location and Site Map of ER Site 22, Storage/Burn**

Environmental Restoration (ER) Site 22 (Figure 1-1) is a small, irregularly shaped fenced area, approximately 50 feet (ft) by 50 ft. The approximately 6.0-ft-high, five-strand barbed-wire fence is in poor condition. No signs or placards appear on the fence, with the exception of the ER site posting. The area inside the fence contains one empty 55-gallon (gal) drum, several wooden pallets, charcoal, and scraps of fiberboard. The top of the drum has been cut off, and the bottom of the drum is discolored from heat, indicating the drum may have been used as a fire barrel. Charcoal is scattered on the south side of the fenced area. The wooden pallets show evidence of past burning, but no burn pit is visible at the solid waste management unit (SWMU). It appears that the only burning that took place at the site was a small wood fire inside the drum. A utility right-of-way that includes overhead power lines and an underground fiber-optic cable cuts the southwest corner of the site.

Figure 1-1 shows the surficial distribution of nonhazardous debris at ER Site 22. The subsurface distribution of debris, if any, is unknown. There is no physical evidence that suggests the presence of hazardous constituents, and there is no documented record of burial activities at this site. The nature and extent of potential contaminants in the soil is unknown. However, no significant contamination is expected to be found. The fiberboard was tested to determine whether it contains asbestos and no asbestos was identified (Appendix A).

The empty 55-gal drum, scrap wood (pallets), burned wood, and fiberboard will be removed from ER Site 22 as part of a voluntary corrective measure (VCM) (SNL/NM November 1994a).

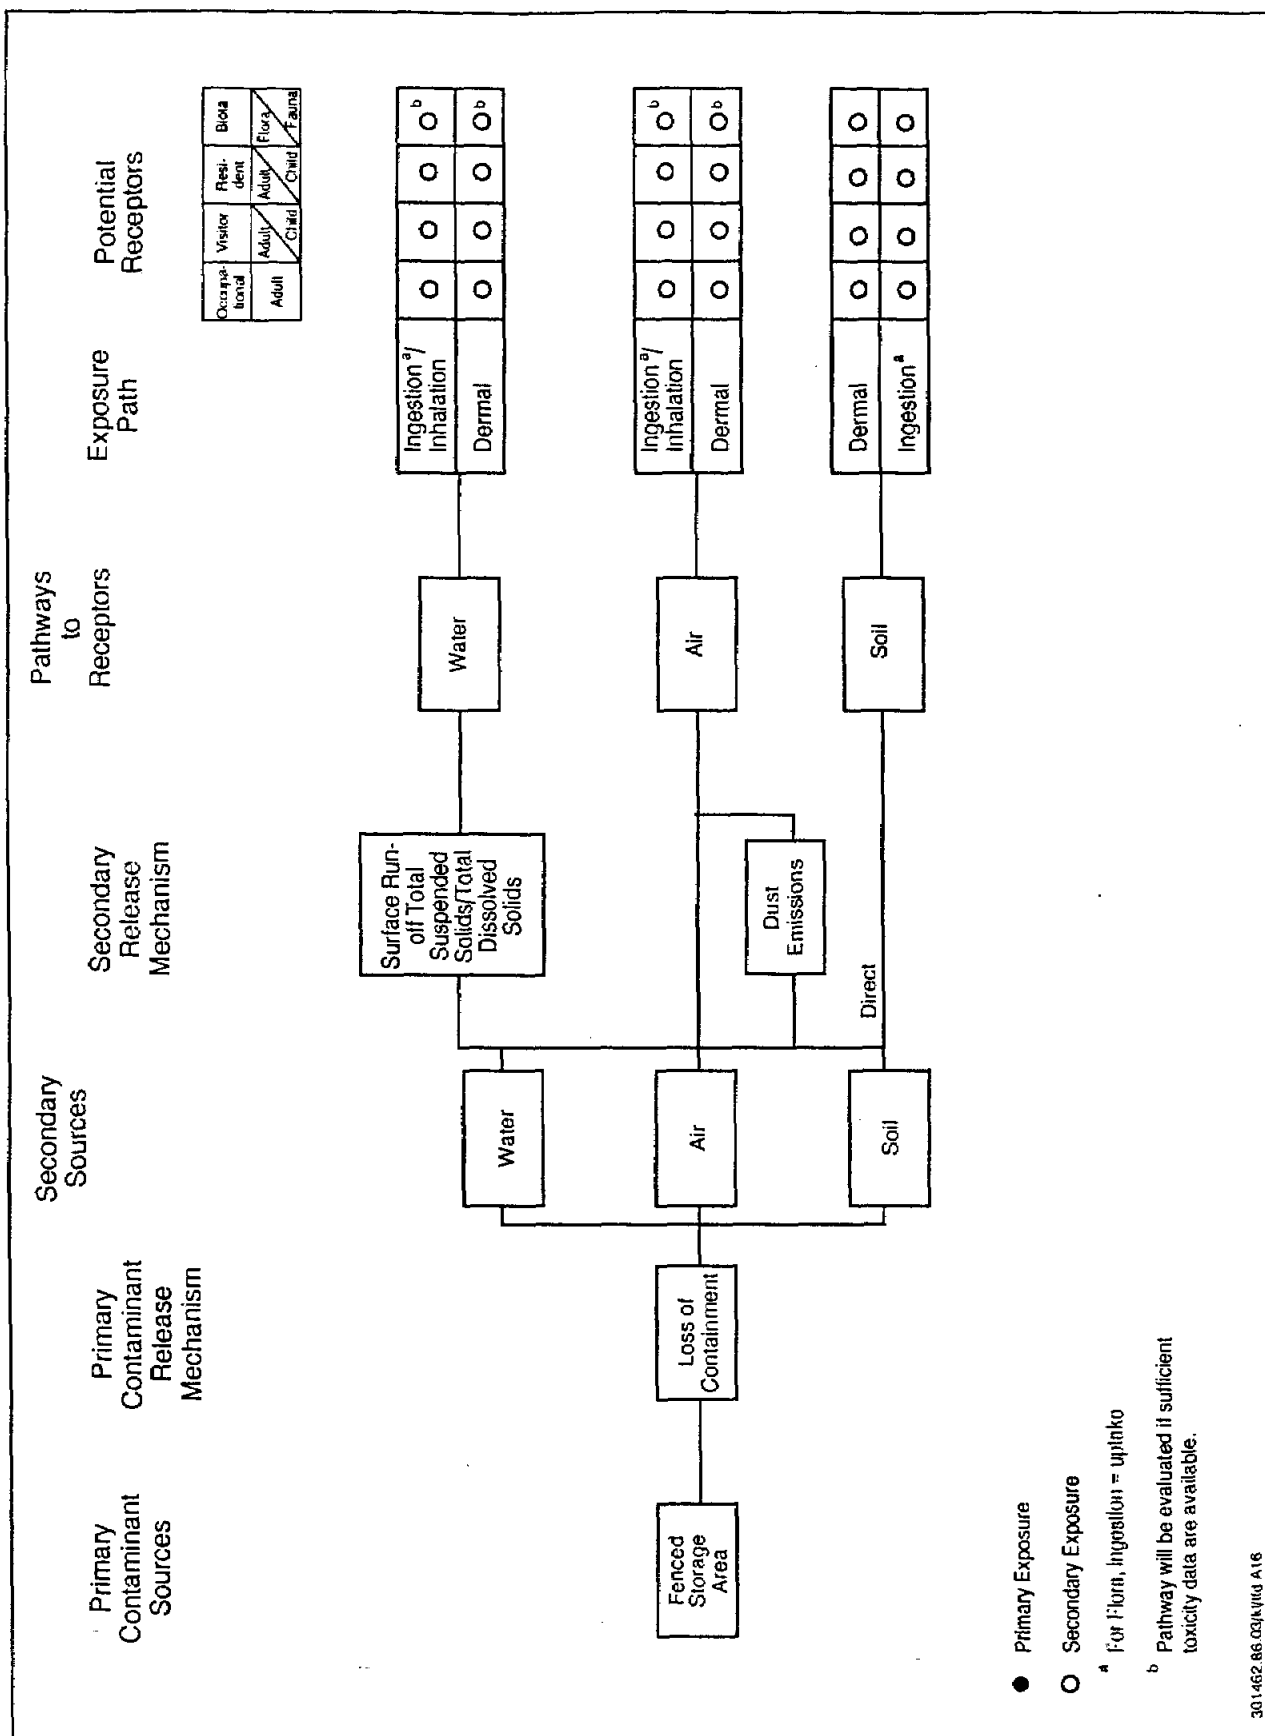
Figure 3-1  
Flow Diagram of Conceptual Model for ER Site 22

Available data do not conclusively demonstrate the presence or absence of hazardous waste or constituents at ER Site 22. The initial conceptual model developed for ER Site 22 (Figure 3-1) consists of a fenced area containing fiberboard pieces, wooden pallets, a small pile of charcoal and burned wood, and a 55-gal drum with the top cut off. Past activities at the site are not documented, but aerial photographs show activity at the time of the construction of the Starfire Optical Range, and ER Site 22 may have been a staging area for utility installation (USDA 1983). Therefore, the potential presence of polychlorinated biphenyls (PCB) will be investigated. The current conditions at the site suggest wood was burned in the 55-gal drum. It is not known if other chemicals were stored or disposed of at the site; therefore, samples will also be analyzed for semivolatile organic compounds (SVOC) and metals.

Figure 3-1 illustrates the potential contaminant migration pathways of air, soil, and surface water, if constituents of concern (COC) are present at ER Site 22. Because scattered debris is subject to wind erosion and transport, air is a potential pathway. Soil near the scattered debris may contain COCs, and contact with such soil results in a direct exposure pathway. The surface-water pathway to receptors is viable because the site lies 50 ft north of an arroyo channel. The depth to ground water at this site is approximately 150 ft (SNL/NM October 1994) and is based on the depth to groundwater in the Starfire Optical Range well (approximately one-half mile southeast of ER Site 22). The limited precipitation, the low permeability of surface soils, and the low infiltration rates (SNL/NM February 1994), preclude ground water as a primary pathway.

Public health and environmental impacts that may be associated with ER Site 22 (Figure 3-1) include ingestion/inhalation and dermal exposure to receptors through the air, soil, and surface-water pathways. Because hazardous materials are thought not to be present on the site, all exposure pathways are considered secondary.

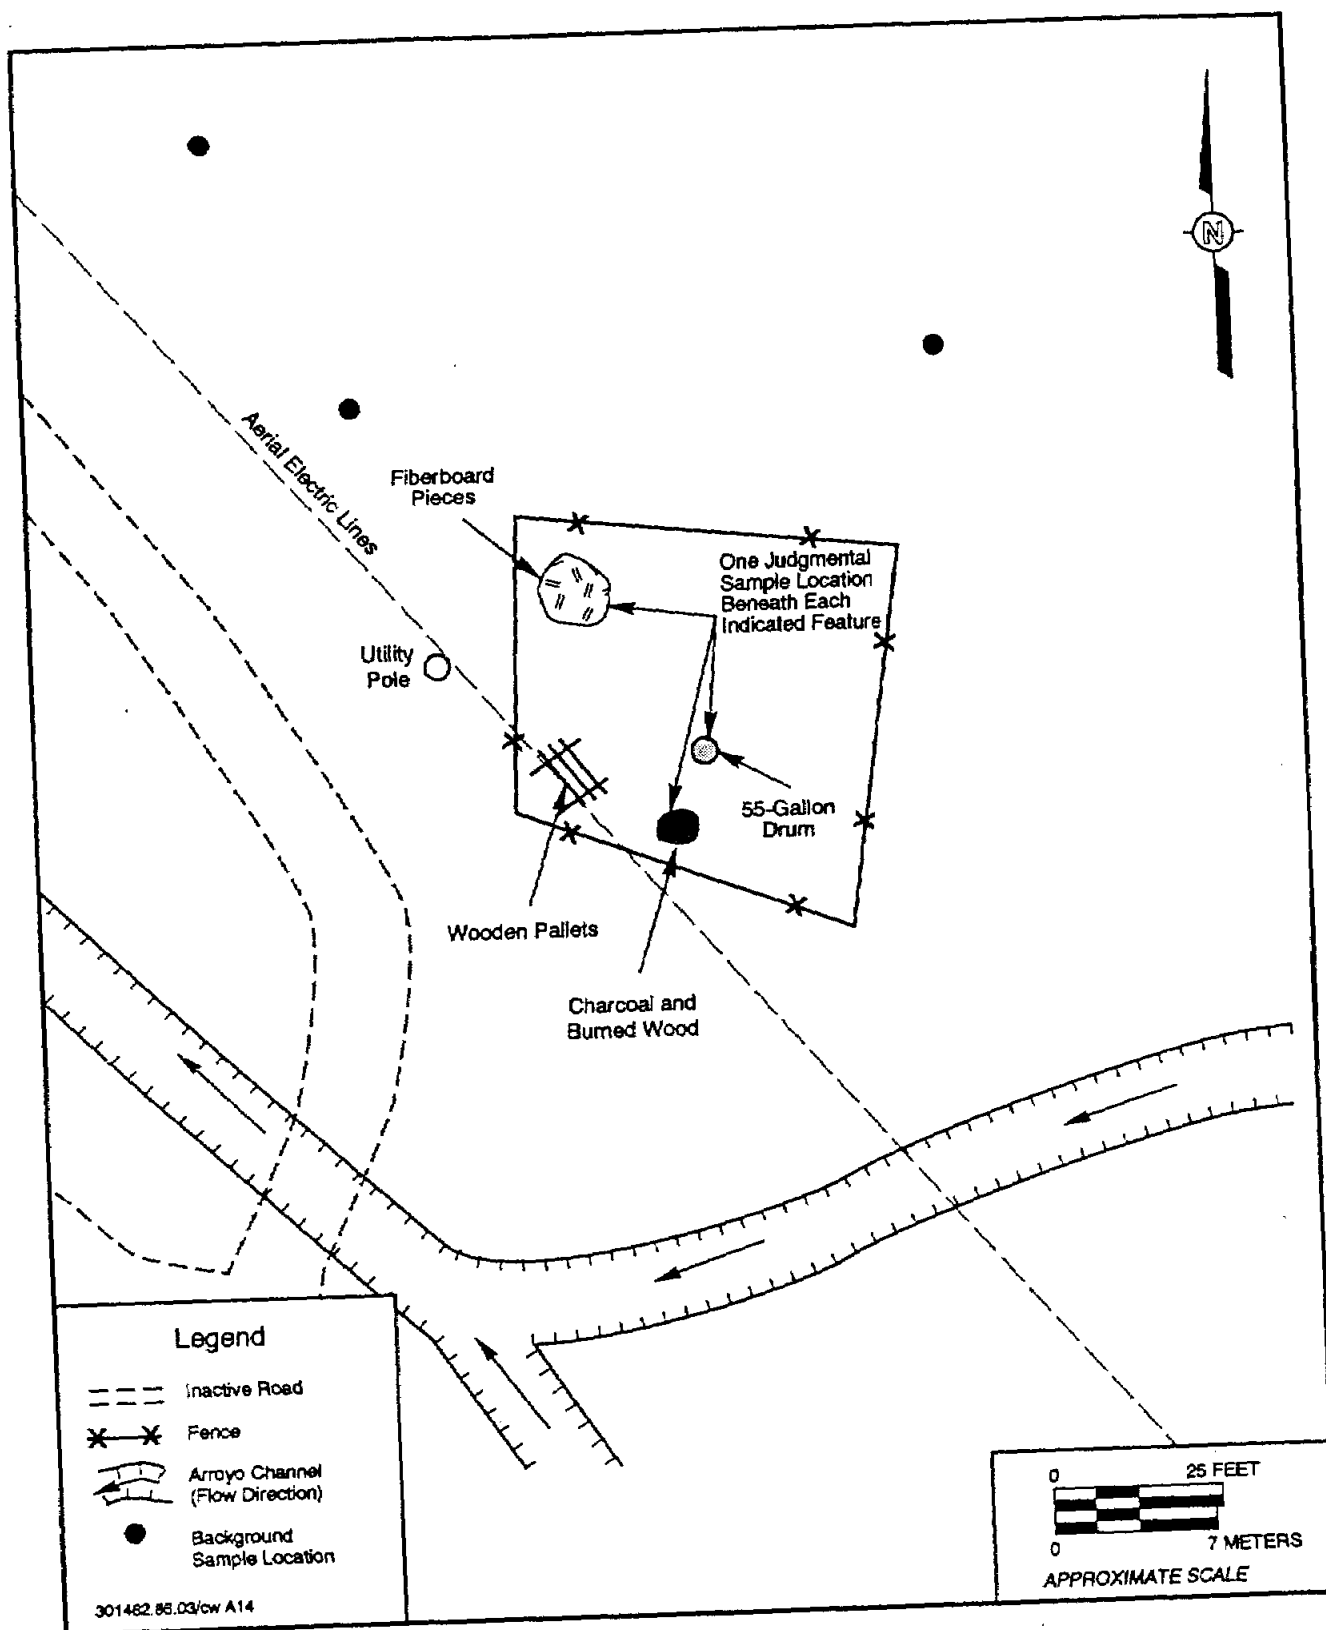
**Figure 6-2**  
**Sample Locations at ER Site 22**

Surface and near-surface soil samples will be collected at three locations (Figure 6-2) to determine site-specific background concentrations for metals and radionuclides. The

Surface and near-surface soil samples will be collected from selected locations within the fenced storage area to determine whether COCs have been released to the environment. Judgmental samples will be collected from beneath the fiberboard pieces, the 55-gal drum, and the charcoal and burned wood (Figure 6-2) at depths of 0 to 6 inches (in.) and 18 to 24 in. Soil samples from the fenced area will be analyzed for SVOCs, PCBs, and metals.
